# LABORATORY TEST REPORT

**Customer:** Fort Mill Ornamental  
**Date:** 2/22/2019  
**Project:** 100276 / CLE02218  
**Product:** ZS311N107, Z series, Super Durable  
**Material Standard:** AAMA 2604-05

**Evaluation:** 7.8.2 Salt Spray Resistance  
**Test Methods:** ASTM B117, Salt Spray Cabinet Conditions  
ASTM D1654, Scribe & blister rating  
**Specimens:** 4 Parts (aluminum fencing pieces)  
Parts were cleaned and pretreated with Calvary Chemical's Zirconium.  
**Exposure:** 3000 Hrs. - Remove & wipe sample dry and Immediately apply tape (Permacel 99 or equivalent).  
**Test Chamber:** Singleton 22  
**Scribed Lines:** One Straight Line  
**Scribing Tool:** Straight Shank, Tungsten Carbide Tip  
**Examinations:** Measure and rate creepage from scribe plus rate appearance of unscribed area  
**Requirements:** Minimum rating of 7 on scribe or cut edges, and a minimum blister rating of 8 within the test specimen field, accordance with Table 1 and 2 (Reference ASTM D1654).

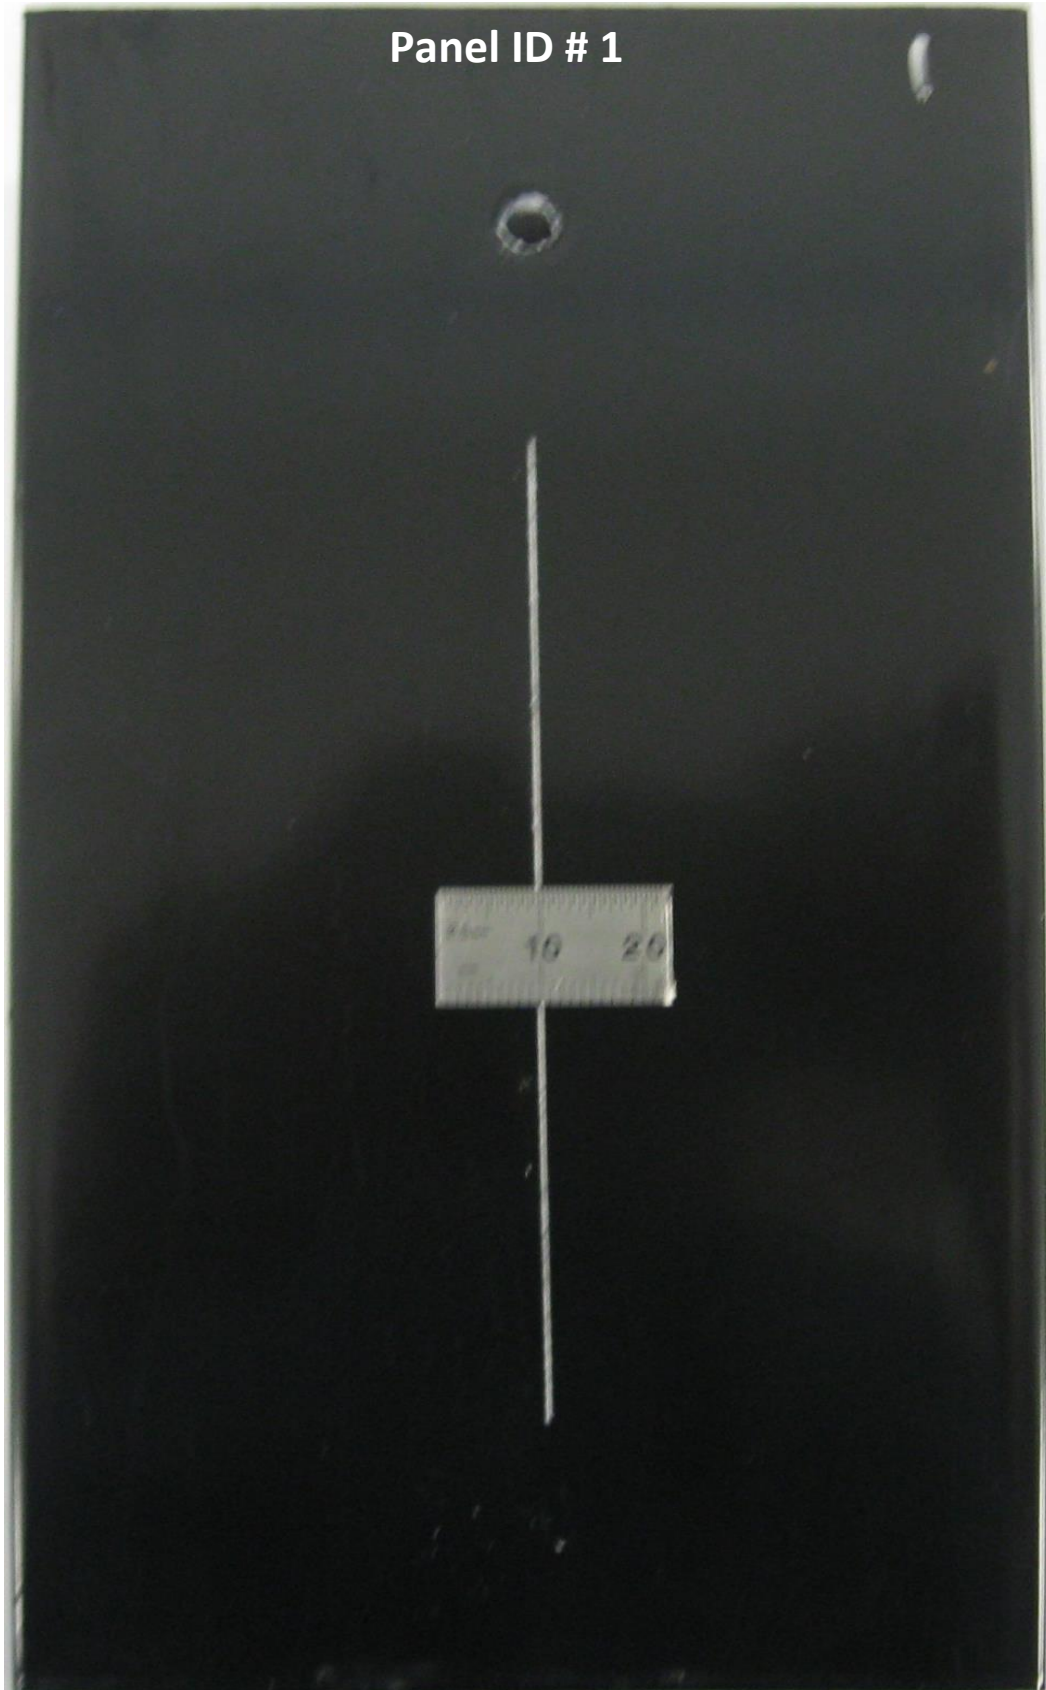
Panel ID	Creepage Form Scribe in mm		Blistering	
	Mean	Rating No.	Area Failed, %	Rating No.
1	0	10	No Failure	10
2	<0.5	9	>3%?	8
3	0	10	<3%	8
4	<0.5	9	<1%	9

**Conclusions:** Parts 1 and 4 both passed for scribe creepage and blistering in the test specimen field. Parts 2 and 3 both passed for scribe creepage and blistering in the test specimen field. The bottom area of Parts 2 and 3 produced a very blistered appearance. This contamination is most probably due to the observed handling of the parts prior to coating and is not representative of the pretreatment or substrate.
